File Number: **320-022003-1070**
Address of Inspection: **1234 Sample Court**

The HomeTeam has agreed to and has performed a visual inspection of the structure located at **1234 Sample Court, Murfreesboro, TN 37127** for **John & Jane Doe** on **Friday, February 28, 2003** by Ron Baker in full compliance with the Standards of Practice and Code of Ethics of the American Association of Home Inspectors (AAHI) and the American Society of Home Inspectors (ASHI). The purpose of the inspection is to identify systems and components of the PROPERTY that in the professional opinion of the inspector, are either unsafe or non-functioning. (Please refer to The HomeTeam Inspection Agreement for clarification, paragraph 1). The inspection was limited to readily accessible areas of the property.

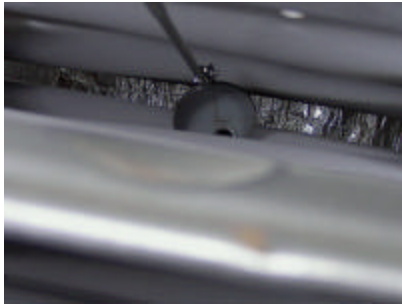
NOTE: Without removing the burners to gain complete access, and with the limited viewing area of the heat exchanger, a thorough inspection is not possible. **However, the HVAC technician removed the top panel to view the heat exchangers and found a crack in all four-heat cells. The technician stated the heat exchanger part was covered under warranty but the labor to the installed the heat exchanger was an additional cost. It is recommended that a certified heating and air conditioning**

The picture on the left if you look into mirror you can see the cracks that were on all four of the heat cells. In the picture on the right it looks like a pencil mark on the heat cell but is a crack.

company be consulted for the repairs.

The heating system was found to be functional. **However, due to the cracks found in the heat exchanger it is unsafe to use and the heat exchanger will need to be replaced as soon as possible.**
